TECHNICAL BULLETIN

No: S514

SERVICE ACTION: Operation of Throttle While in Closed Position

XJ (X308)

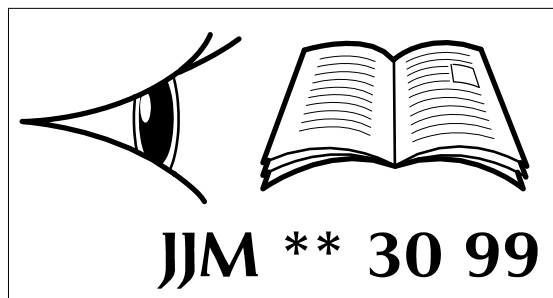
ILLUSTRATION 11

Note: The new throttle body has a Molykote coating and cannot be cleaned. The new throttle bodies can be identified by a sticker (Illustration 11).
