Technical Bulletin

87 18 06 April 17, 2018 **2019947** Supersedes Technical Bulletin 87-17-12 (V871712) dated November 9, 2017 to add new flushing device adaptor 6338/74 for Jetta, including 2018 Jetta, Passat and Beetle.

Air Conditioning, Cleaning of the Refrigerant Circuit (U.S. Only)

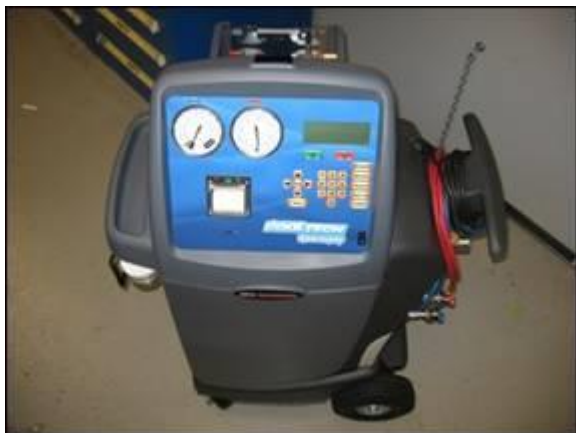
Figure 1. The ROB134APF Air Conditioning Service System with VAS 6337/1A Air Conditioning System Flushing Device.

- **Use the ROB134APF Air Conditioning Service System with VAS 6337/1A Air Conditioning System Flushing Device (Figure 1)** Used for effective refrigerant handling and air conditioning circuit flushing after air conditioning component failure.
- Now air conditioning system refrigerant recovery, evacuation, recharge and refrigerant circuit cleaning after component failure can be performed with a single servicing station.

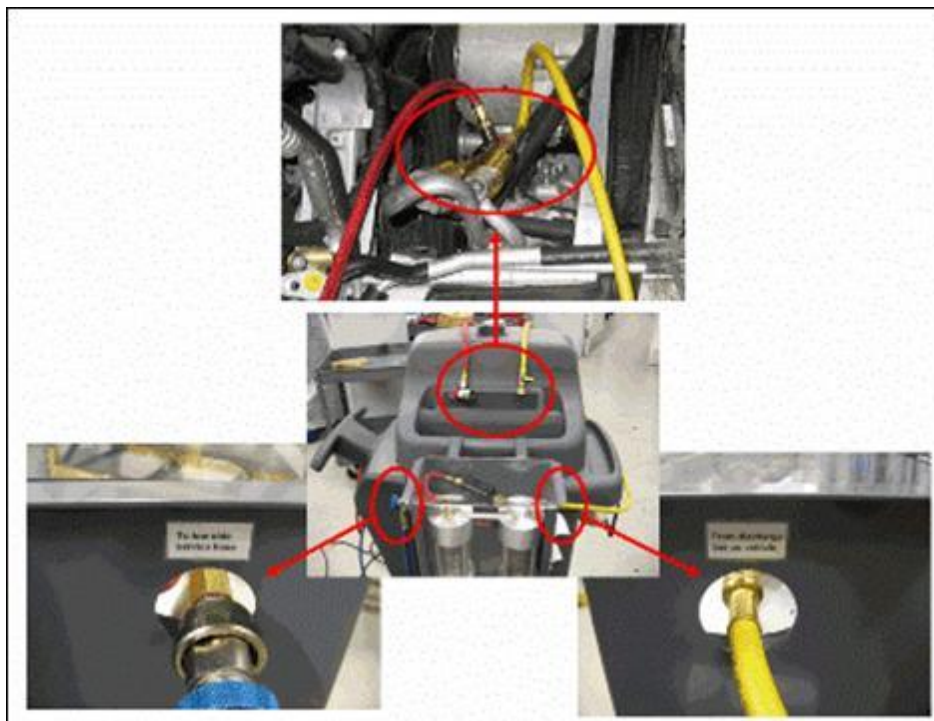
- This connection strategy allows for a system flush ***in the opposite*** direction of the normal refrigerant flow (Figure 3).

Figure 3. Connection strategy: Vehicle to service station to flushing device.

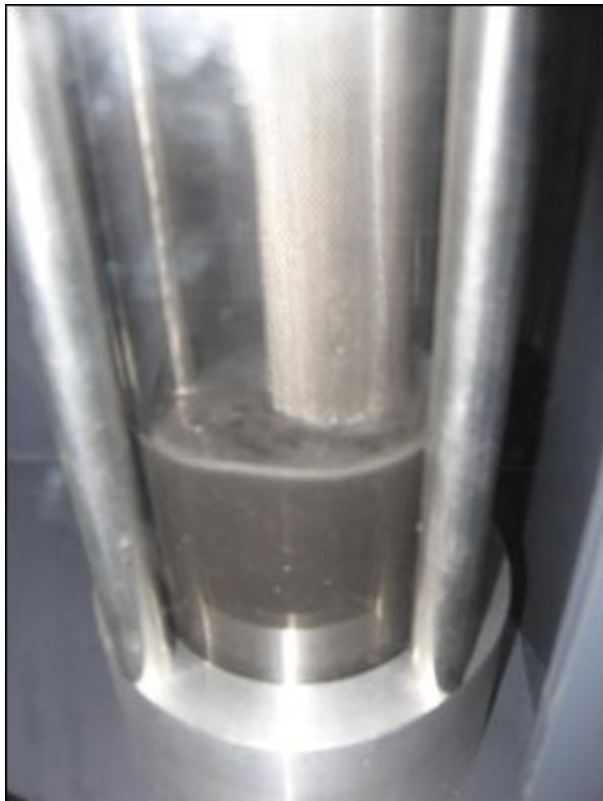
Figure 4. The first cycle.

- The flush program will begin with an evacuation of the system and a rate of rise test. This is necessary to test the integrity of the connections before the flush cycles begin. If the rate of rise test passes, the program will proceed into the flush cycles. (Figures 4 – 6). These cycles will occur automatically in succession.

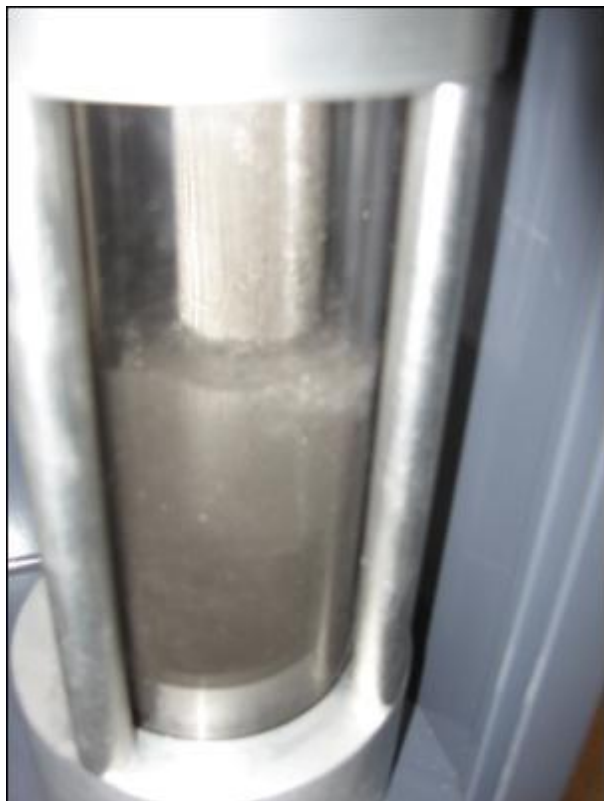
Figure 5. The second cycle.

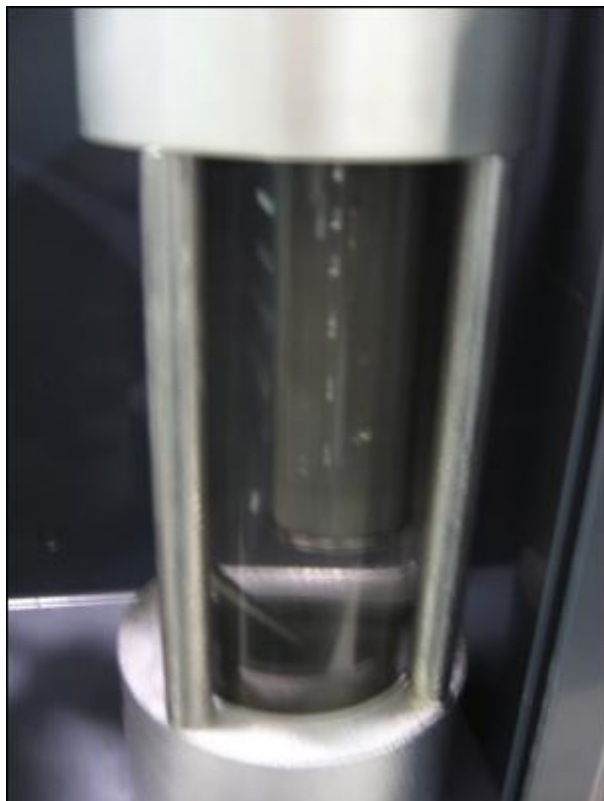
Figure 6. The third cycle.

- The debris is then rinsed from the circuit and contained within the filtration in the flusher. After the flush program, the system will be evacuated.
5. After the system is evacuated, remove any adapters that were installed from the VAS 6338/1.
 6. Replace Expansion Valve (if equipped), Receiver-drier and Restrictor (if equipped).
 7. Connect the station in the usual manner through the service fittings and perform the normal evacuation and refrigerant recharge operations.
 8. Print a log of the job and attach to the repair order.

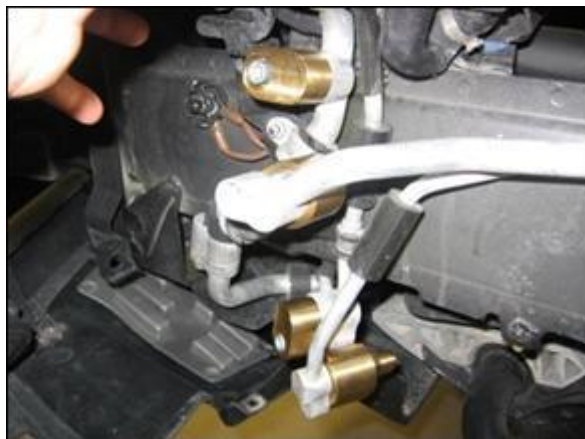
Figure 7. The location of the connections inside the left front wheelhouse on a Touareg with four zone climate control.

1. Separate the front and rear air conditioning systems for individual rinse operations (Figure 7).

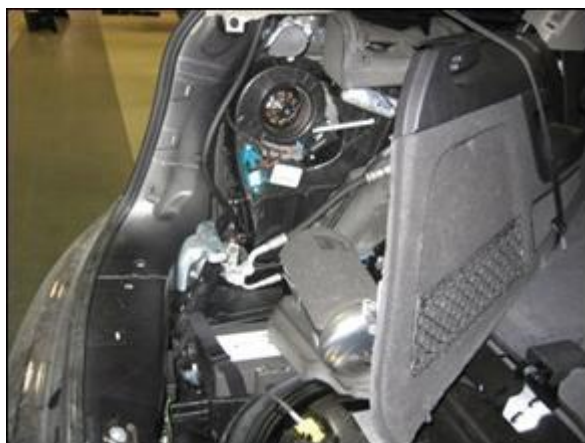
Figure 8. Location of rear air conditioning unit and expansion valve.

2. Bypass the rear expansion valve with an adapter (Figure 8).

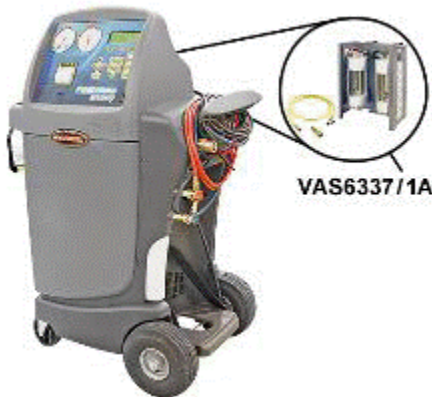
ROB134APF
<p>Air Conditioning System Flushing Device</p>

Tool Description	Tool No:
<p>Air Conditioning Service System.</p>

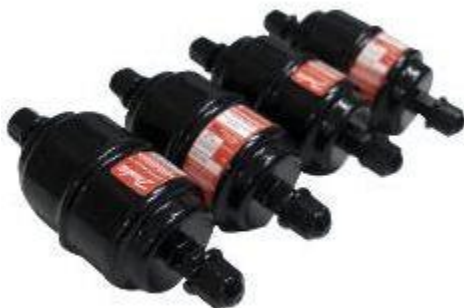
Behr – BAI783400103

Air Conditioning System Flushing Device Filter

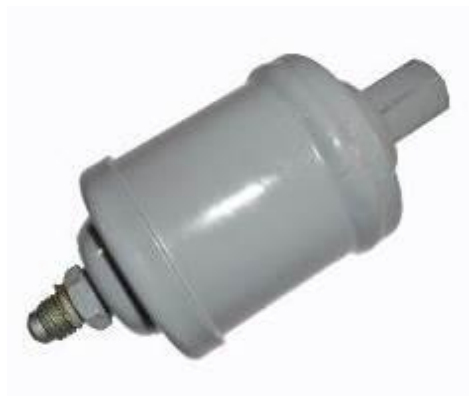
Bosch – 17707-6

Air Conditioning System Flushing Device Filter

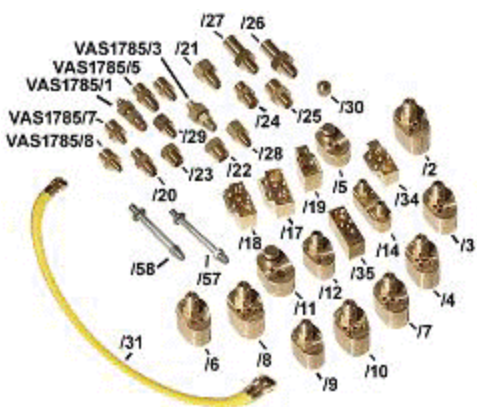
Adapter set for refrigerant circuits

The VAS 6338/1 Adapter Set for Refrigerant Circuits. Along with an additional adapter (VAS 6338/33 for the front expansion valve bypass for the Touareg) this kit contains the adapters necessary to complete a thorough flush operation of a contaminated circuit.

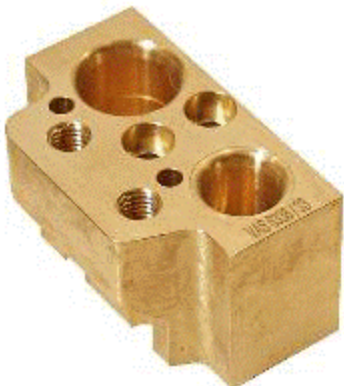
<p>Additional adapter 33 for bypass of the front expansion valve for Touareg</p>

<p>A brass adapter with four large ports and two smaller threaded ports. The part number VAS 6338/33 is stamped on the side.</p>	<p>VAS 6338/33</p>
<p>Additional refrigerant circuit adapter 36</p>

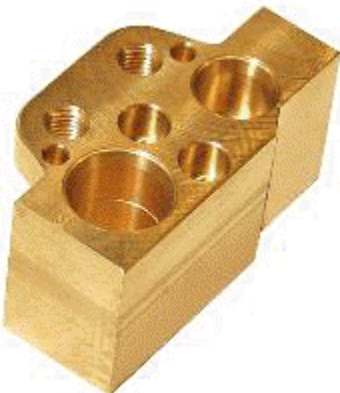
<p>A brass adapter with four large ports and two smaller threaded ports. The part number VAS 6338/36 is stamped on the side.</p>	<p>VAS6338/36</p>
<p>Additional refrigerant circuit adapter</p>
